KORFF + CO.KG Luftfahrttechnischer Betrieb LBA II-A 189 Dieselstrasse 5 D-63128 Dietzenbach/GERMANY	SERVICE BULLETIN SB-KOCO 03/818	TAIFUN 17E
		AUSGABE 01 ISSUE

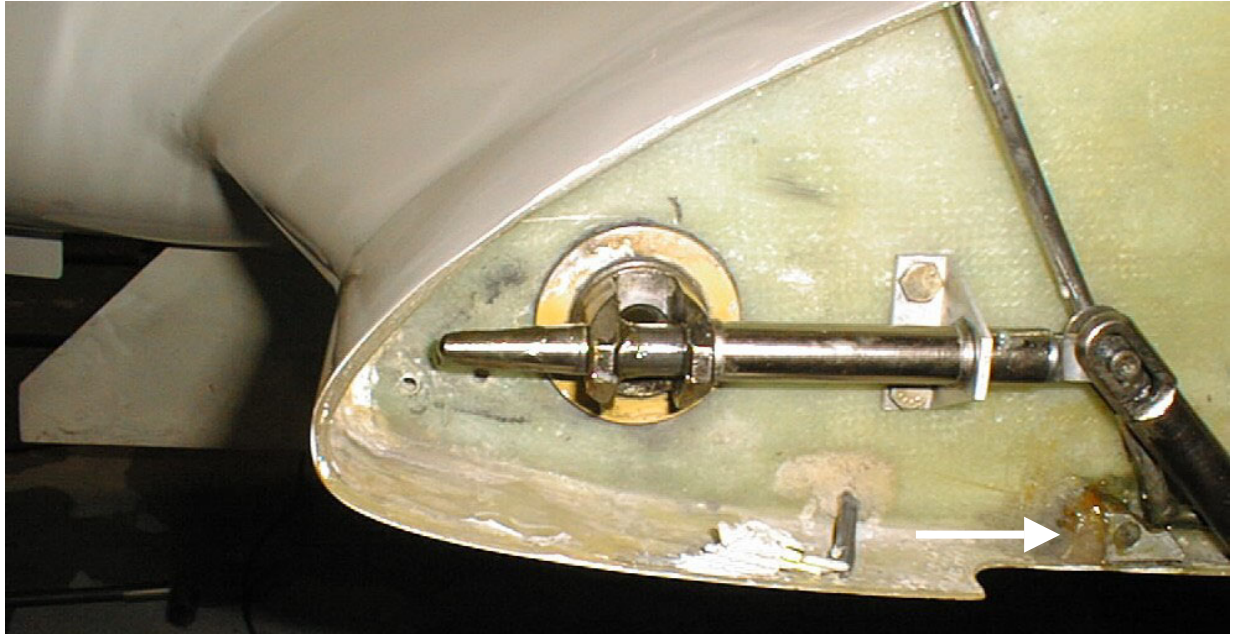
Picture 1: Bolt in full locked front position, can be moved backwards by hand because of worn out stop key F1-1300.

6. Renewal of stop key F1-1300. Screwing can be reached easily through the hole in the root rib. Additional to the screwing the stop key will be embed into a epoxy resin / cotton flocks mixture. During mounting it is necessary to pay attention to the item that the bolt can't be moved by hand more than 2 mm backwards from the full locked front position after the new stop key F1-1300 was adjusted. If this can not be guaranteed, the whole shear force fitting has to be disassembled to find out the reason. In this case please contact the type supporter KORFF + CO.KG for further information.

After mounting the new stop key an operational check has to be carried out in derigged and rigged configuration. During the operational check in rigged configuration the correct function of the signal pin (in level with upper wing surface), bolt movement to full front stop position and correct locking function have to be inspected through the operating hole under stub wing leading edge.

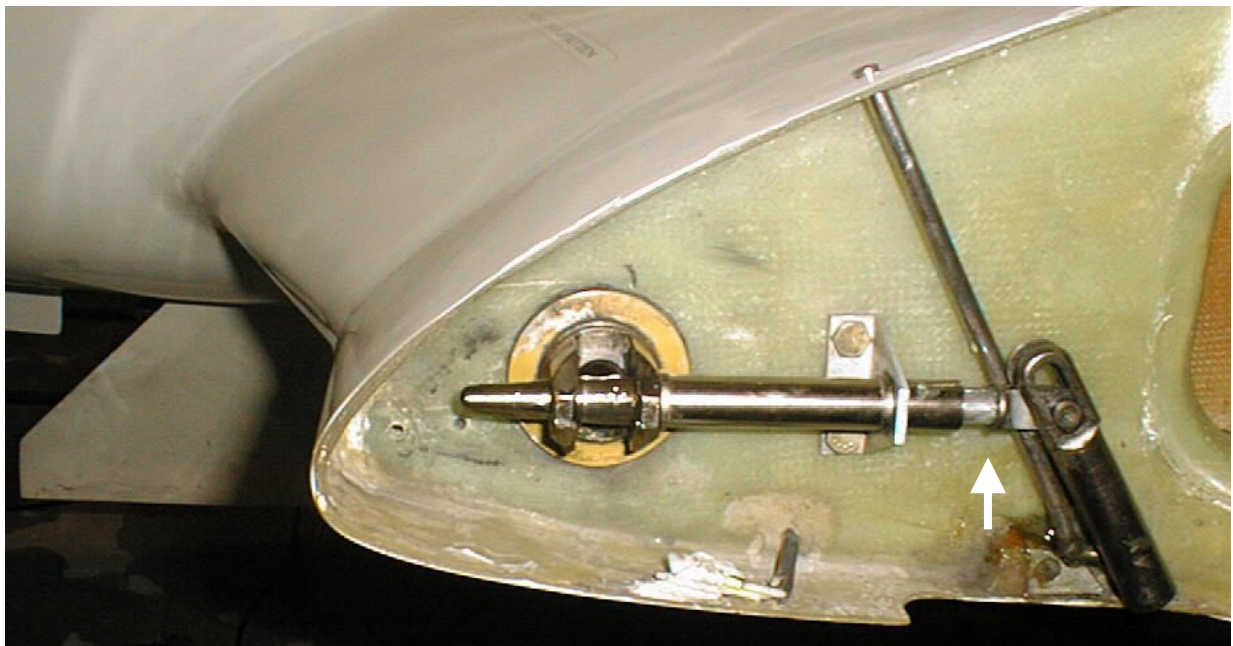
Picture 2: Bolt moved backwards because of worn out stop key F1-1300.
