Muster: PDPS (Polen)
SZD-50-3 "Puchacz"

Flugsteuerung / Landeklappen ("inspection of torque tube in air-brake control system")

DYREKTYWA ZDATNOSCI - AIRWORTHINESS DIRECTIVE
Nr SP-0052-2003-A

MANDATORY BULLETIN
No BE-052/SZD-50-3/2003 „PUCHACZ”

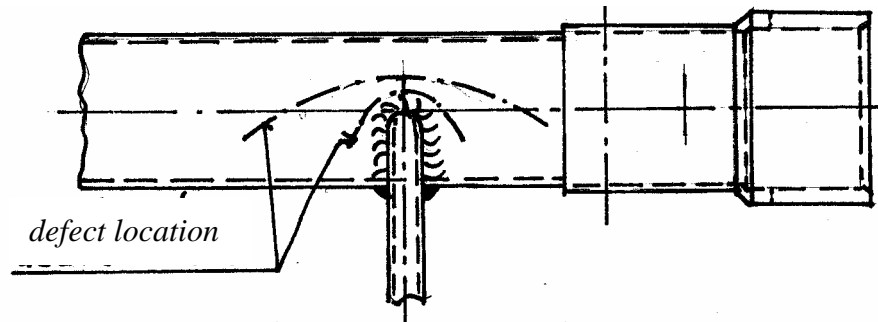
In-flight, while operating the air-brake, over recent 12 years, several cases of the torque tube break-off from the located in fuselage lever have been stated. Damage occurred at the welded joint between these a.m. elements (dwg. No 503.64.30.00). This damage rendered in-flight retraction of the air-brake impossible.

Possible cause might be material fatigue in the area of frequent occurrence of striking load, exceeding recurrently the JAR-22 recommended value, as well as the detected in last case corrosion inside the opened tube.

- 3.2.5. take the torque tube out from the fuselage, raising it up-, and fore.
- 3.3. Check the condition of torque tube in the area of welded joint with lever (see sketch):

- 3.3.1. check with reading glass of 3x magnifying power, at minimum, if cracks of weld or tube in the area of welded joint can be found.
- 3.3.2. check if permanent distortions to cylindrical shape of tube can be found
- 3.4. Check if inside the torque tube, especially in the area of welded joint, any evidence of corrosion can be found.

- 4.1. Cracks, permanent distortions of torque tube, as well as corrosion pit on tube inner side in the area of welded joint are not permitted.

If any one of the above listed defects has been detected – tube must be replaced with new one, purchased from Allstar PZL Glider.

- 4.2. Slight, uniform corrosive deposit should be removed with fine abrasive paper (grid 600, at minimum). If no corrosive pits are present on a surface, after application of anti-corrosive agent (e.g. FLUIDOL) can be operated further on. Replacement with new one is recommended, however.
